# Addendum to Test Report No. C1020QPEN

## 1 Purpose of the Addendum

This addendum summarizes the results of a extended mechanical load test. The intention of the test is to find the maximum wind and snow loads that are acceptable for the collector with the SPF test number C1020. The extended mechanical load test is carried out according to the procedure given in EN12975, but with increasing loads up to a failure of the collector or the test installation. The collector is installed according to the installer manual of the manufacturer

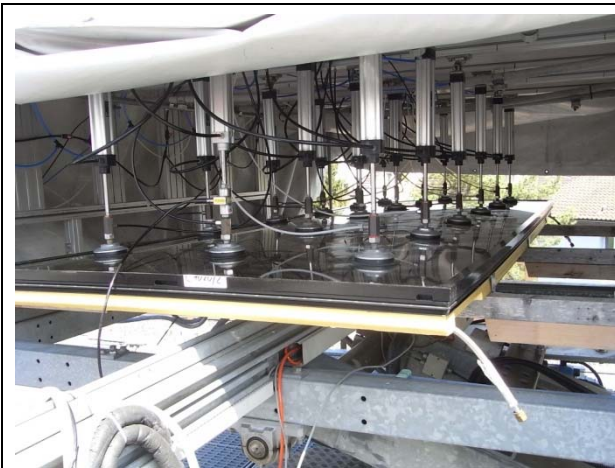
Picture 1

Evenly distributed pneumatic suction cups are used to apply the positive and negative forces. Number of suction cups is 18

18 suction cups evenly distributed over the collector surface. Positive and negative forces applied up to 2500 Pa.

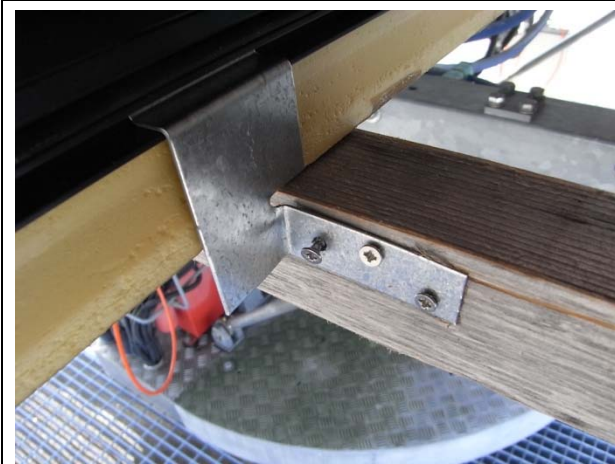
Picture 2

At loads exceeding 2000 Pa a certain deformation of the hooks and the screws used for the installation was observed. The battens used to simulate the roof split apart.

No structural problems observed for the collector and its casing for loads up to 2500 Pa. The screws that were delivered with the collector are not strong enough and are too short. Furthermore it is important to use three screws per hook and not only two as shown in the installer manual. It is important to use sufficiently strong battens.

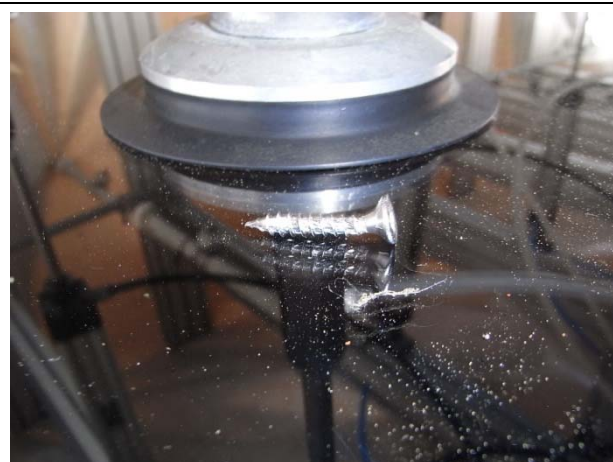
Picture 3  
One of the screws used to fix the collector.

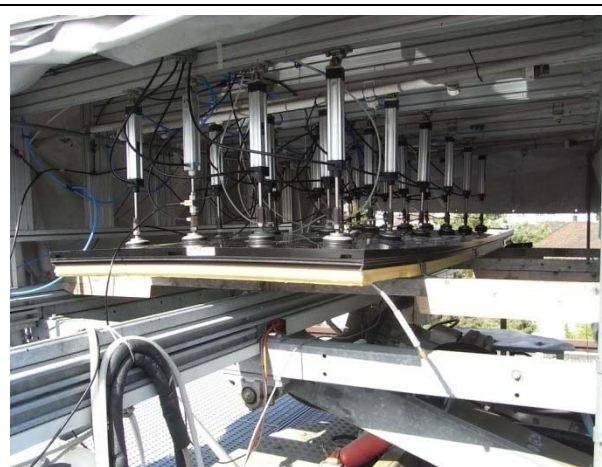
To apply higher loads the number of suction cups is increased to 24. The screws used to fix the collector were replaced by stronger screws. The battens were reinforced.

Picture 4  
24 suction cups evenly distributed over the collector surface. Positive and negative forces applied up to 3250 Pa. On the picture uplifting force of 3200 Pa is shown. No problems observed

Using the stronger screws, three screws per hook and reinforced battens, no structural problems are observed for the collector and its casing for positive and negative loads up to 3250 Pa. Strong deformation of the collector during the application of the force. The deformation is reversible and therefore not considered as a problem.

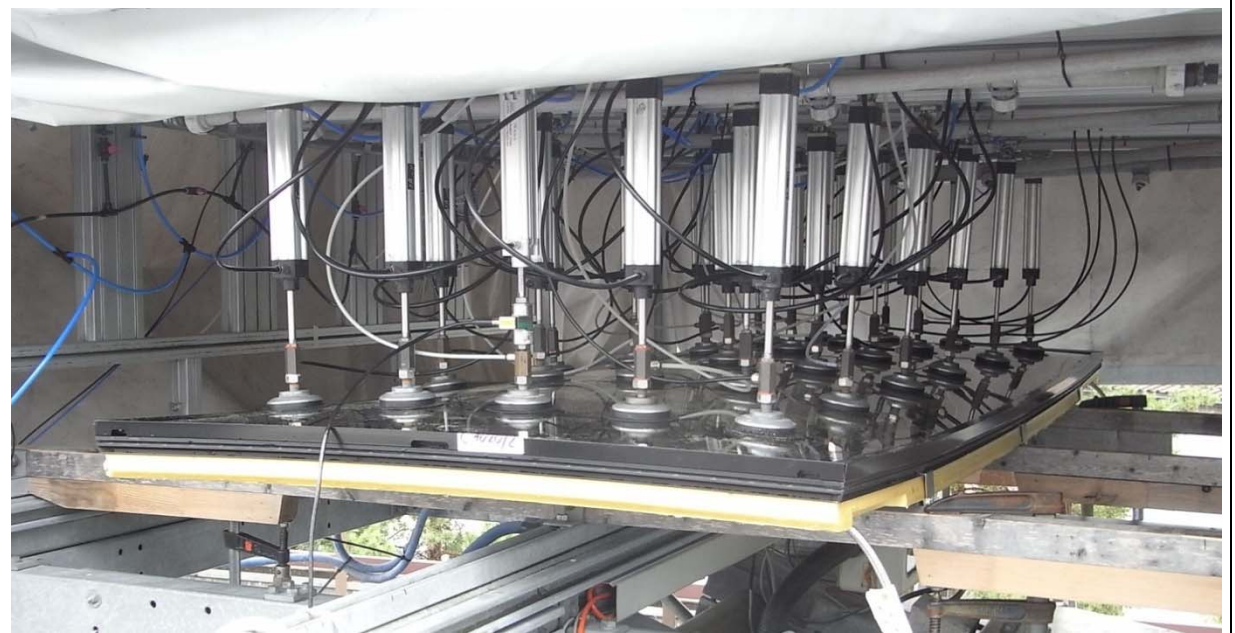
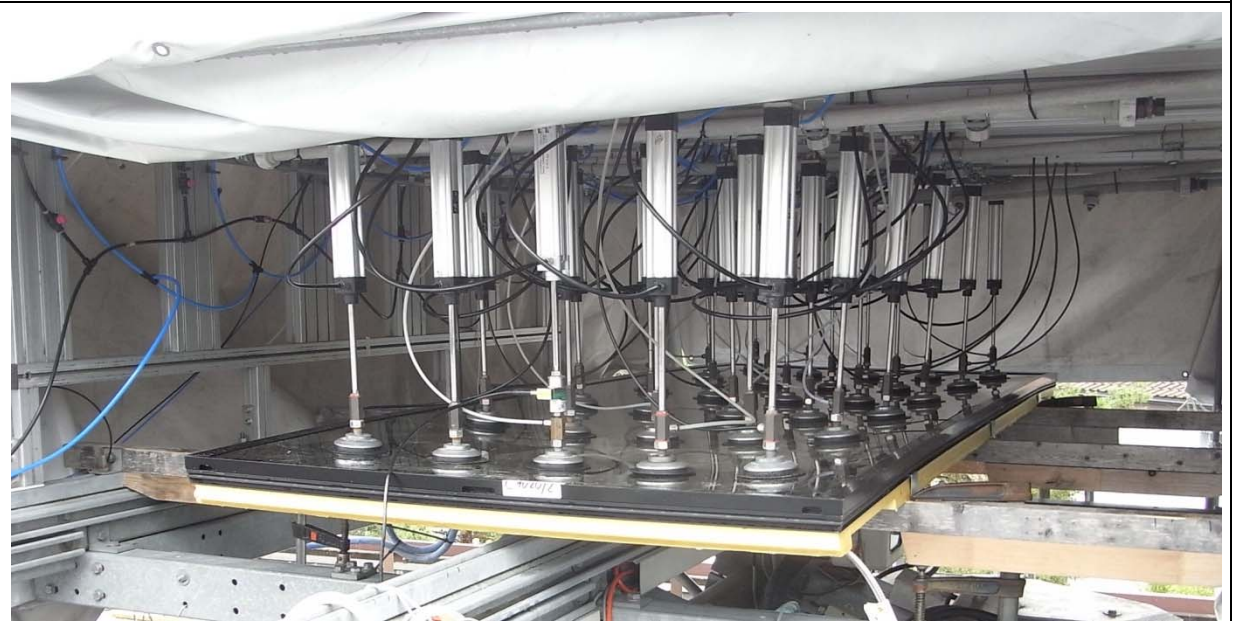
Picture 5, 6

To apply higher loads the number of suction cups is increased to 30.  
Else the installation is the same as described in stage 2.

30 suction cups evenly distributed over the collector surface. Positive and negative forces applied up to 4100 Pa. On the pictures the maximum negative load (top) and positive load (bottom) of 4100 Pa is shown. Higher loads are not possible with the current installation.

No problems observed.

The collector Viridian Clearline V30 was tested for excessive wind and snow loads of up to 4100 Pa. No structural problem of the collector and its casing were observed. The mounting system used to install the collector on the roof is sufficient provided that at least three screws per hook are used and that the screws are of good quality and sufficient length. When installing the collector for extreme wind and snow loads high quality of battens with appropriate dimensions must be used.
